VEHICLE INSPECTION REPORT

BH19SWV

Nissan E-Nv200 80KW ACENTA 40KWH

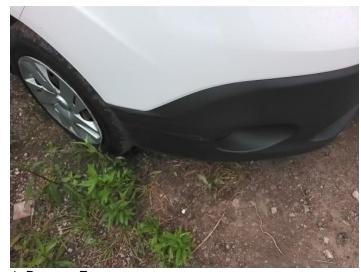
1: Bumper Front Scratched Over 100mm Thru Paint

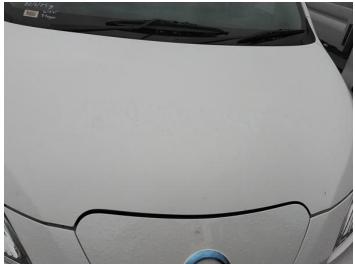
2: Bonnet Chipped Multiple Chips

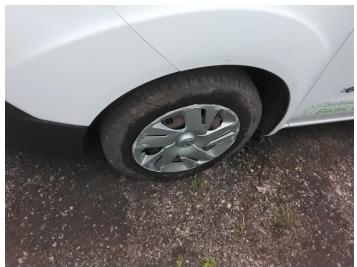
3: Wheel Trim nsf Broken Replace

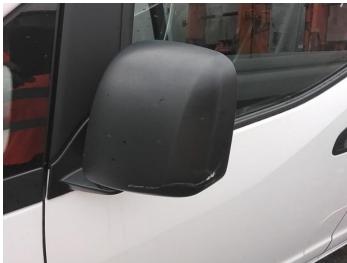
4: Door Mirror Assy nsf Scuffed (Unpainted) Over 100mm

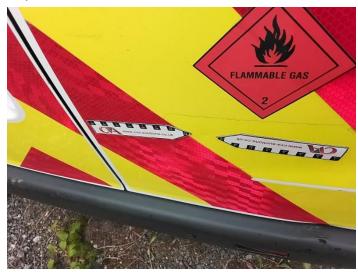
5: Door osr Dented Over 30mm

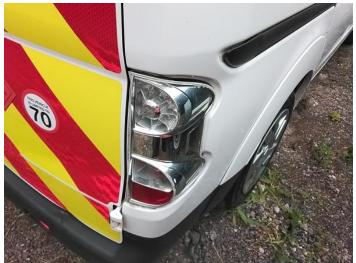
6: Lamp osr Broken Replace

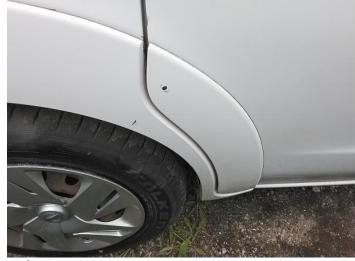
7: Qtr Panel osr Chipped Multiple Chips

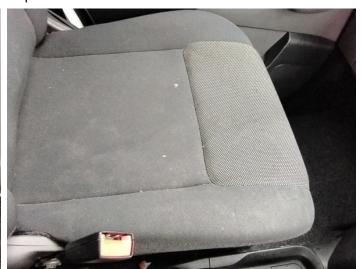
8: Seat Base Cover nsf Soiled Heavy
